# Irrigation and Soil Moisture Analysis for Floodplain Riparian Restoration

# Grabau, Matthew R.<sup>1</sup>, Bangle, Dianne<sup>2</sup>, Milczarek, Michael A.<sup>3</sup>, and Lindsey Hovland<sup>3</sup>

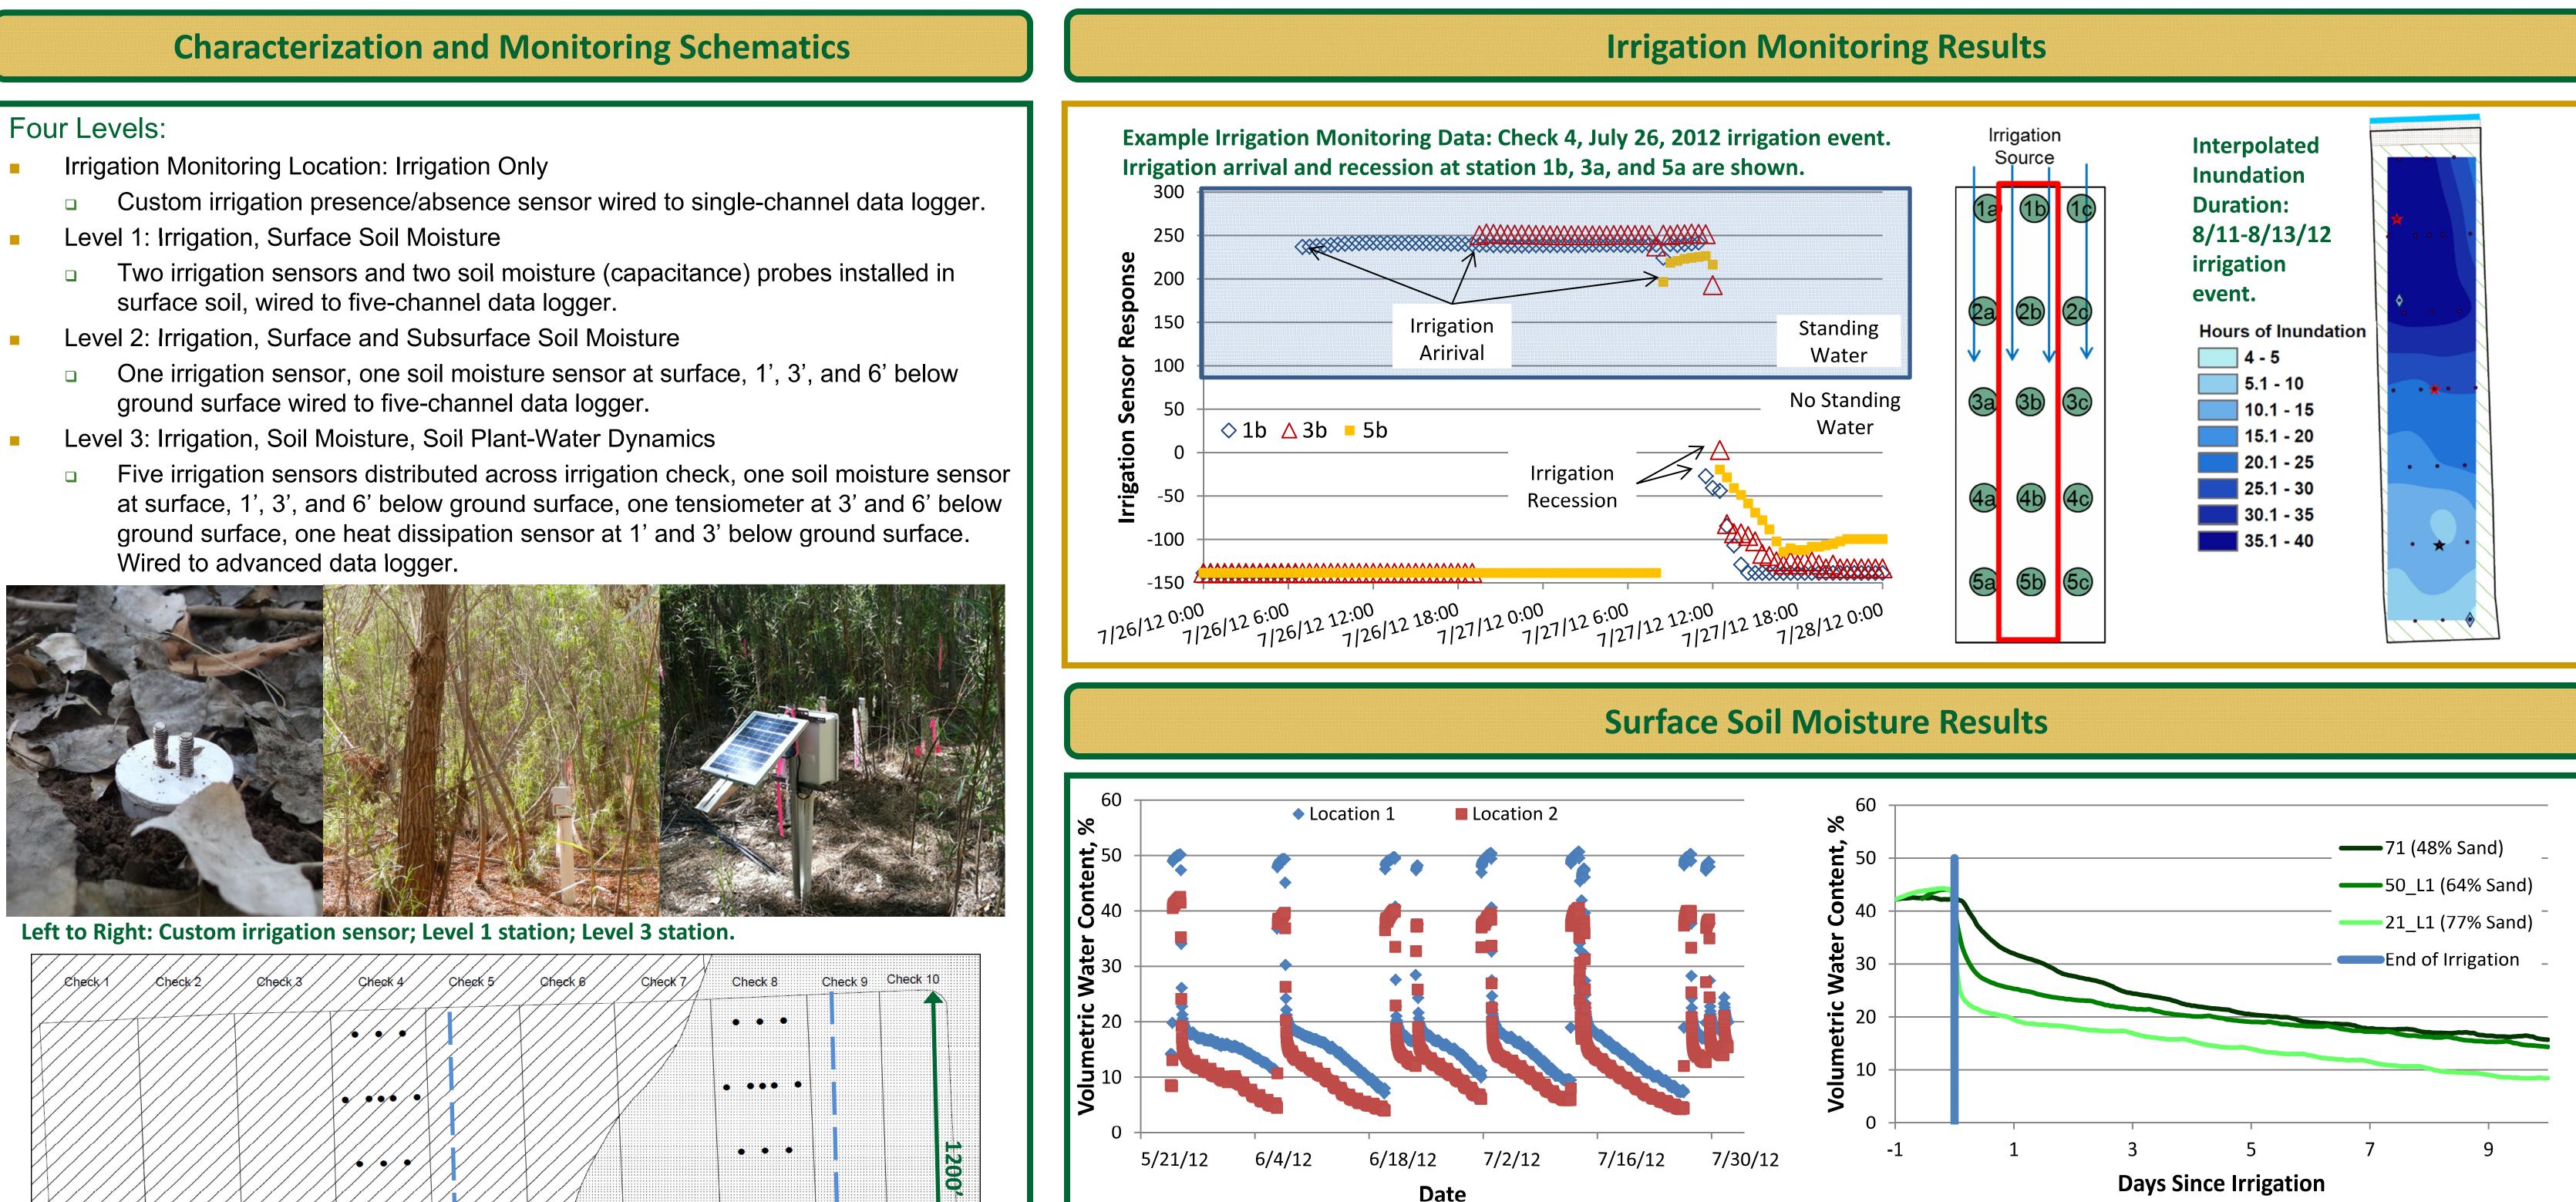
events followed by soil drainage.

Surface soil moisture for June and July 2012 at Level 1 Station 45,

with a 0-6' composite sand fraction of 78%. Peaks indicate irrigation

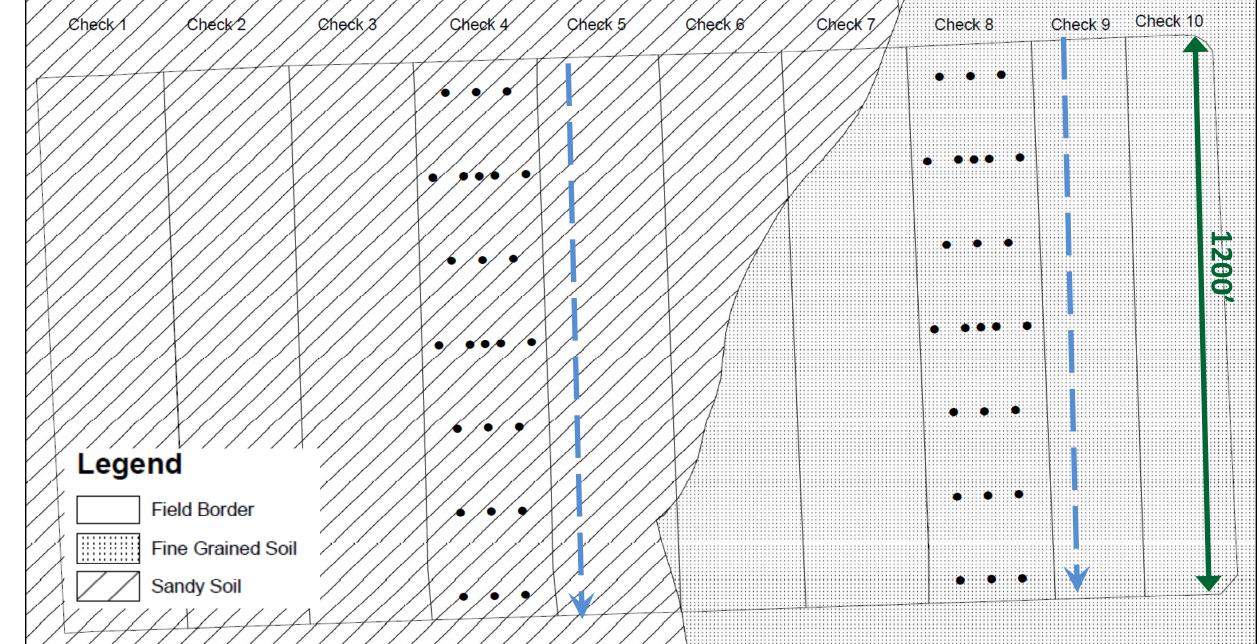
Dense irrigation monitoring grid to provide high-resolution in two different soil classes Arrows indicate direction of irrigation flow.

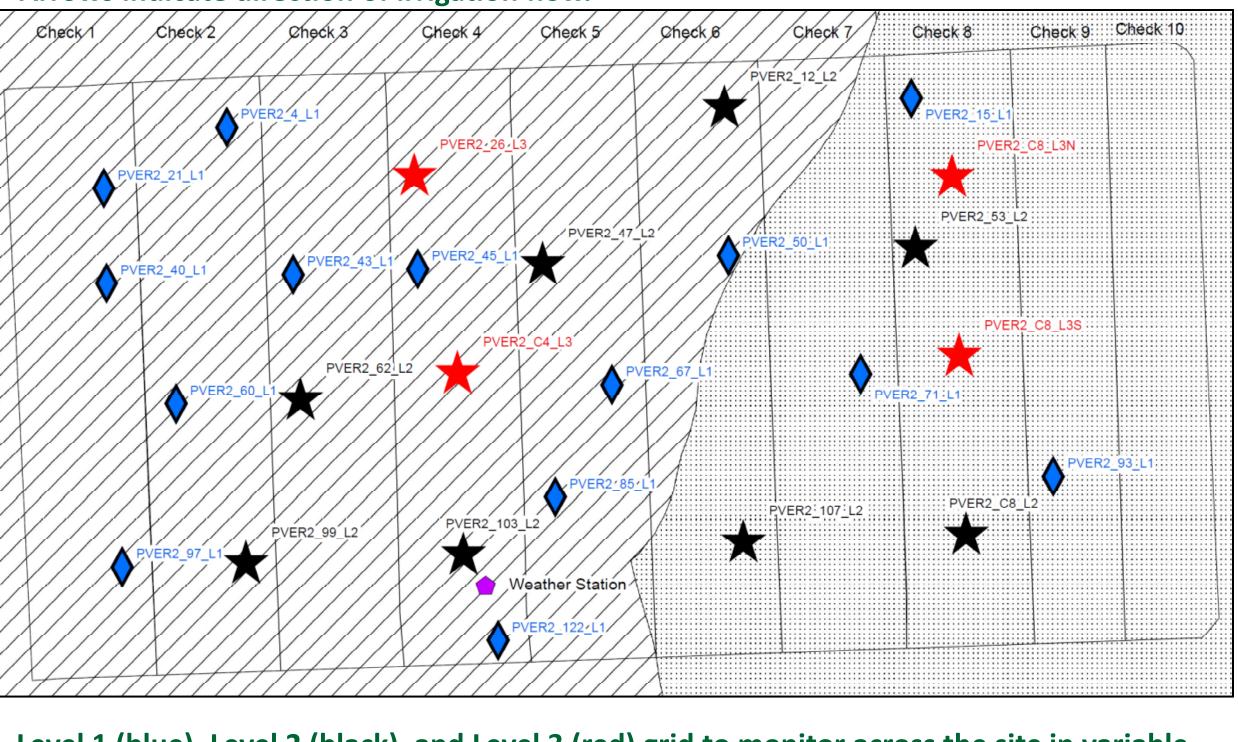
Level 1 (blue), Level 2 (black), and Level 3 (red) grid to monitor across the site in variable vegetation species and density and the range of observed soil classes

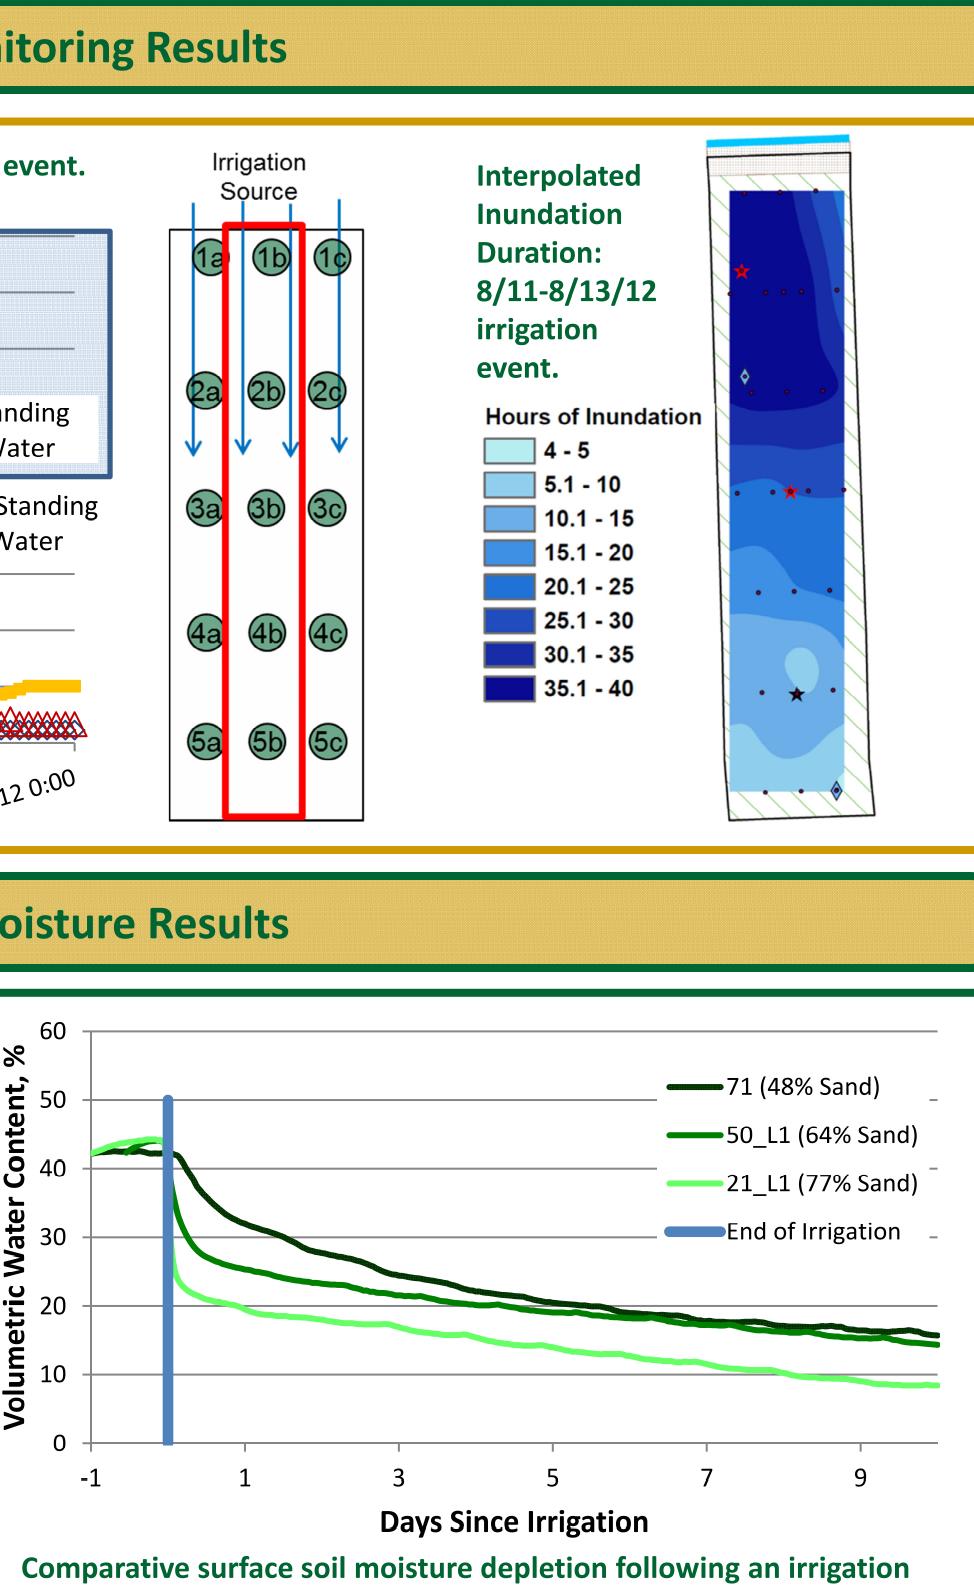
Surface (0"-2" below ground surface) and subsurface soil moisture following a July 2012 irrigation event at Level 2 Station 47, with a 0-6' composite sand fraction of 80%. Following irrigation onset, water quickly percolates through the soil profile. Drainage occurs rapidly after irrigation ceases.

event in July, 2012. Sandy soils drain quickly after irrigation. Thereafter, soil moisture reduction is driven by evapotranspiration.

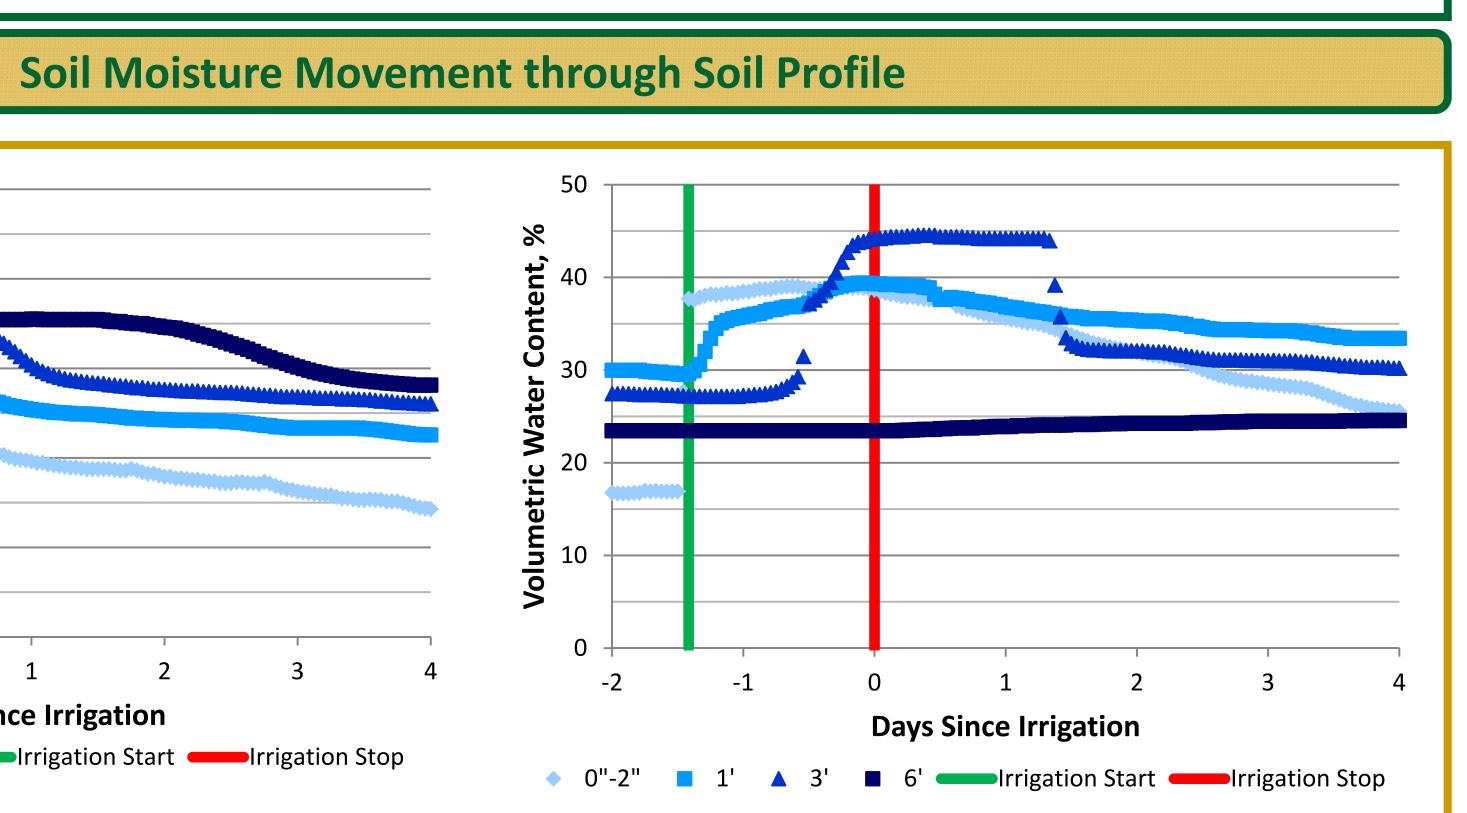
Surface (0"-2" below ground surface) and subsurface soil moisture following a July 2012 irrigation event at Level 2 Station 53, with a 0-6' composite sand fraction of 54%. Little percolation is observed.

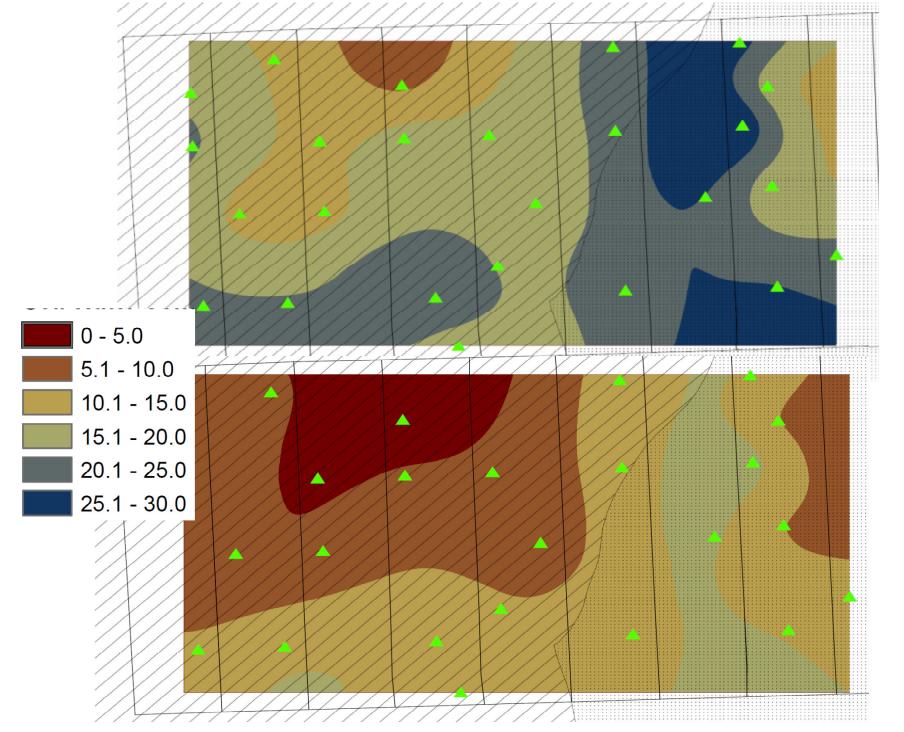
Monitor and quantify soil moisture at restoration sites for a desired time horizon. Example: Average July 2012 volumetric water content (top), and minimum July 2012 volumetric water content (bottom).
